AN ARCHÆOLOGICAL ASSESSMENT  
OF THE  
ROMANO-BRITISH IRONWORKS  
ON THE  
BEAUPORT PARK ESTATE  
BATTLE, EAST SUSSEX

# **BEAUPORT PARK ROMAN BATH HOUSE**

## **Appraisal of Conservation Options**

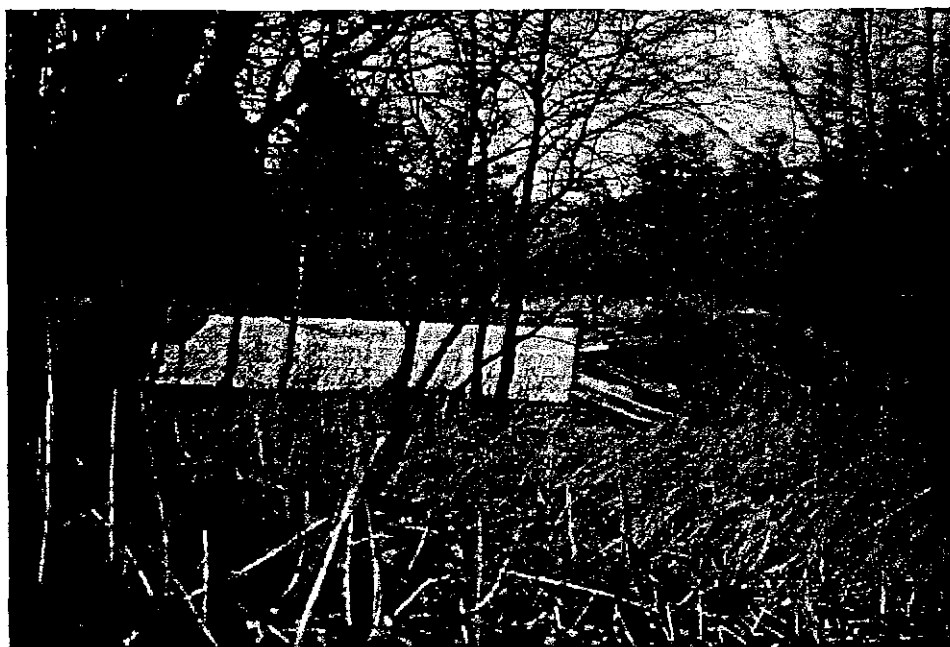
Photograph 1 View of protective roof over the bath house from the south showing its location within a depression in the landscape (March 2001)

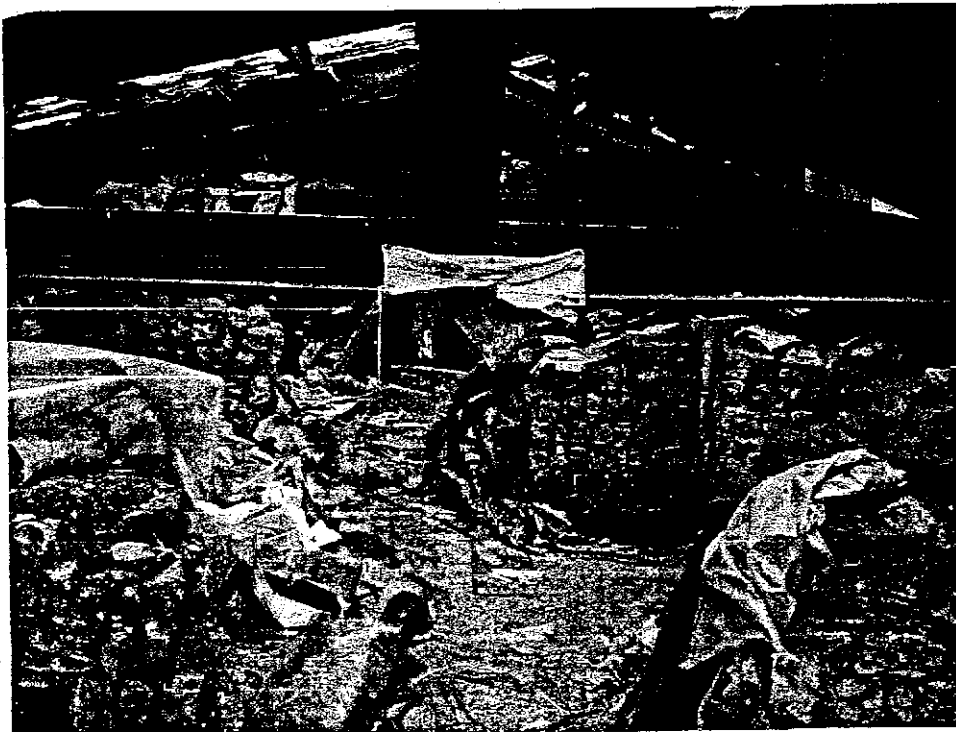
Photograph 3 Internal view looking west from room II. Plastic sheeting has been removed from the walls for inspection

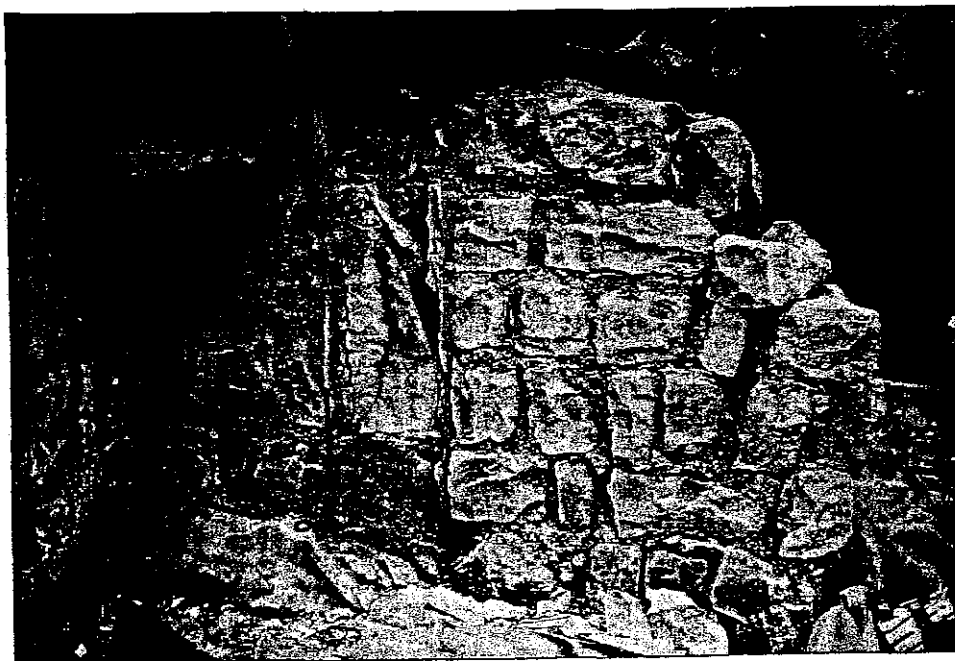
Tile is, in general, porous and permeable and therefore susceptible to moisture movement and damage from crystallisation of soluble salts and from frost, albeit to a lesser extent than the mortar and plaster. Box flue tiles in the south west corner of V exhibit delamination and spalling typical of frost damage.

**Photograph 8** South west corner of room V showing damaged box flue tiles and unstable masonry which urgently requires temporary support

Any other structurally unstable masonry should be supported laterally, either with sand bags or timber shores, depending on the location.

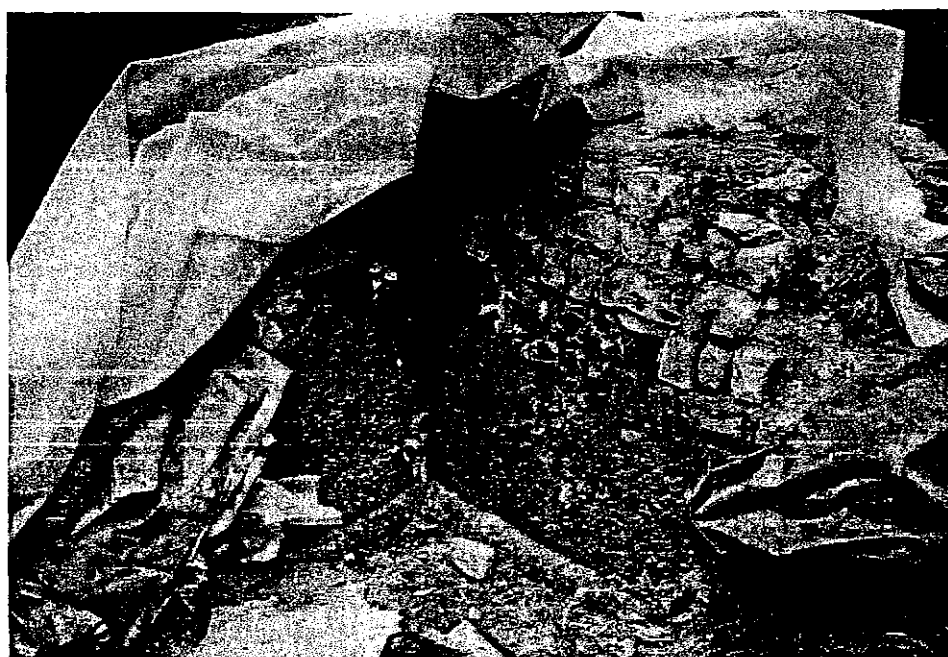
**Photograph 11** South west corner of room II. As in the photograph above, areas covered by transparent plastic sheet appear to support more organic growth than those covered in opaque black plastic

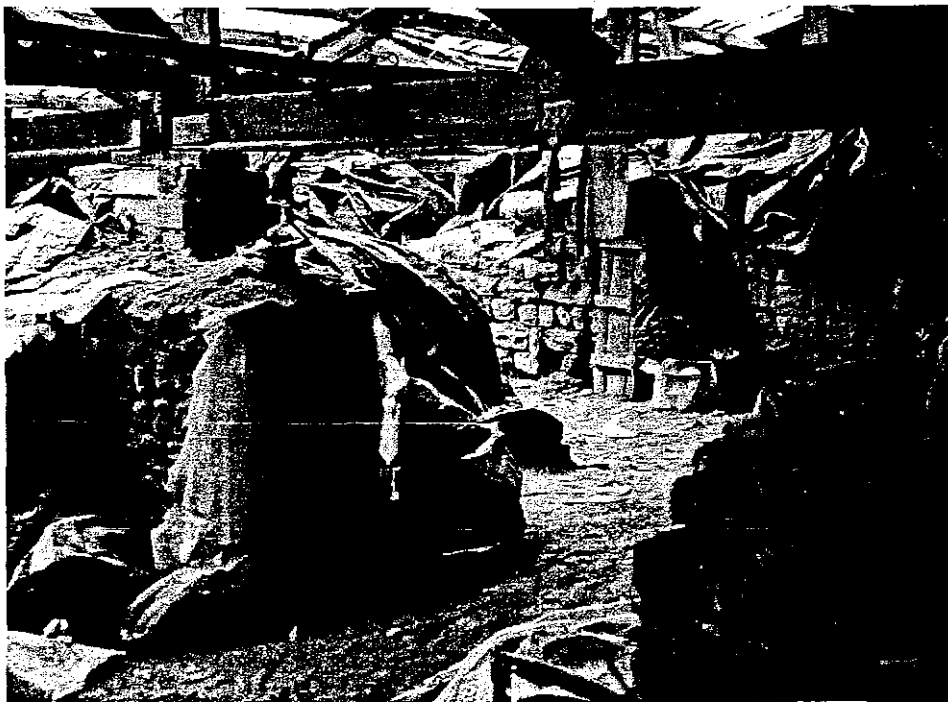
The bath house walls currently bear the load of the protective roof structure at corners formed between rooms. This is far from an ideal situation and it would be desirable to devise an independent support system especially bearing in mind damage which could result from any movement of the roof.

Photograph 12 View of the centre of the bath house (room 1) looking west and showing roof timbers resting on bath house masonry
